# Boston's Open Space

1987  
PARK EVALUATION  
&  
SITE SUMMARIES

EVALUATION OF  
CITY OF BOSTON  
PARK AND RECREATION LAND

NEIGHBORHOOD OF HYDE PARK

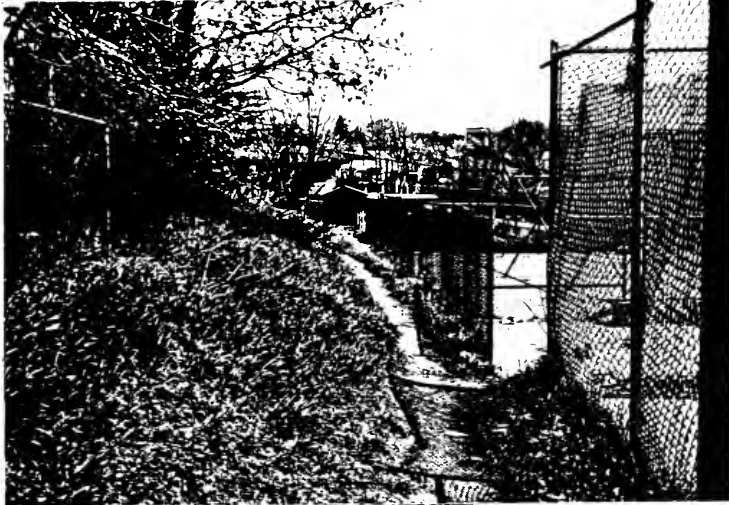
### Site Photograph 1

Two chain link fences create wasted and difficult-to-maintain space. This shows short-cut desire line.

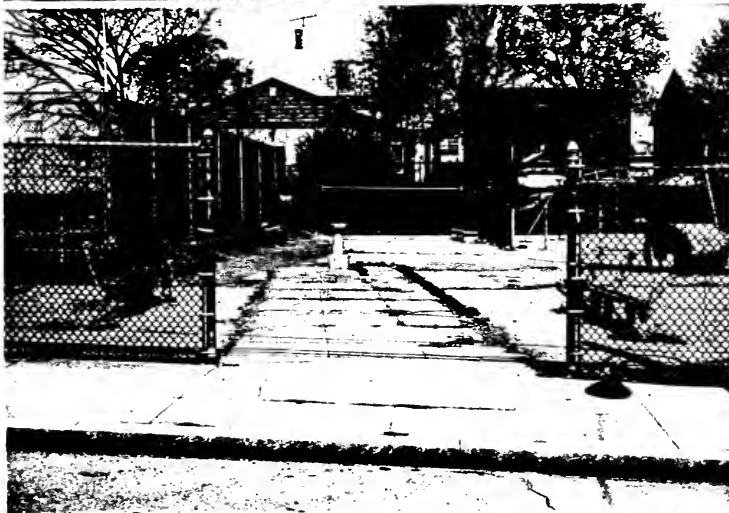
### Site Photograph 2

Entrance into park showing destroyed benches, weed growth and trash. No trees or grass.

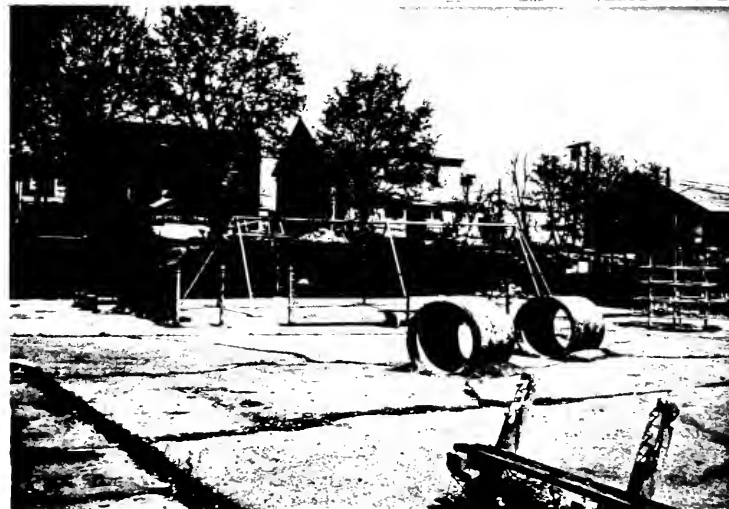
### Site Photograph 3

Swings unusable, benches in need of repair, equipment needs painting.

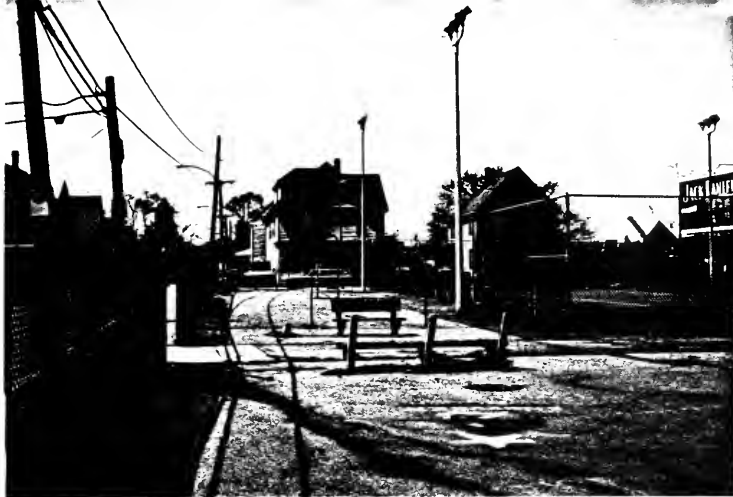
#### Site Photograph 4

Park lacks plantings -  
excessive pavement

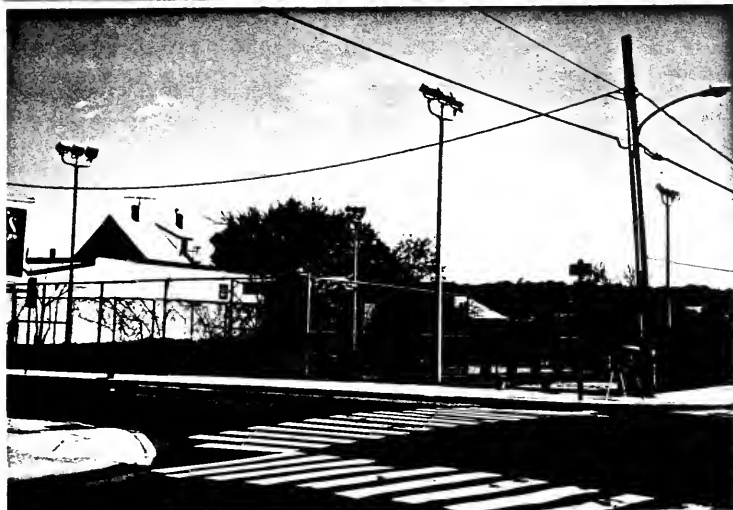
#### Site Photograph 5

View of park from  
across street. Tennis  
court recently converted  
from basketball. Park  
has bleak character.

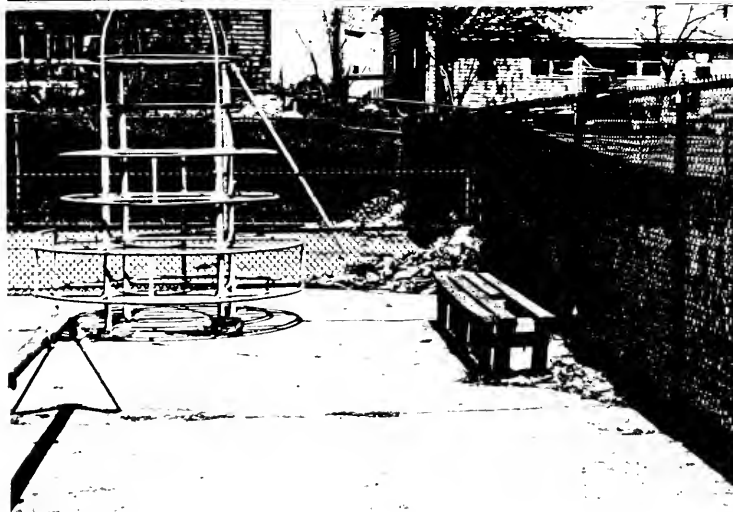
#### Site Photograph 6

Lack of maintenance -  
trash and leaf build-up.

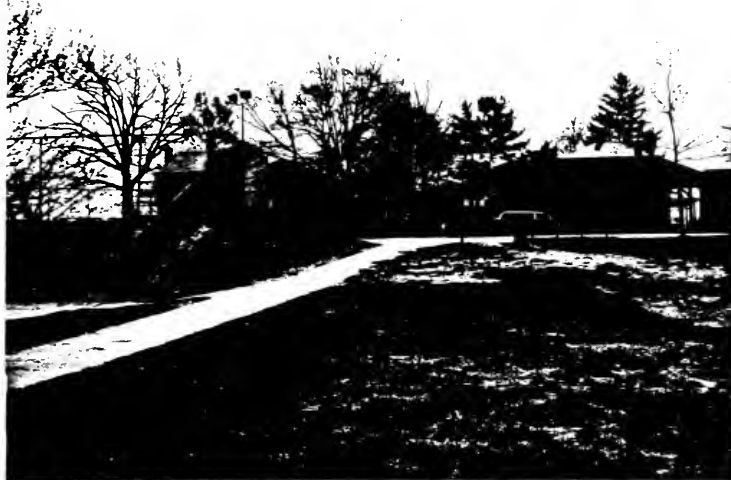
**Site Photograph 4**

Erosion problem - water sheet draining off basketball and tennis courts-eroding slope.

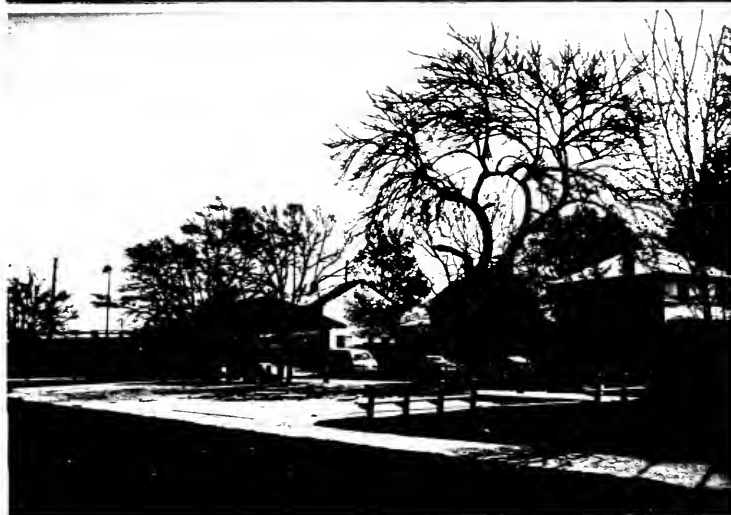
**Site Photograph 5**

Playground - No equipment other than swings.

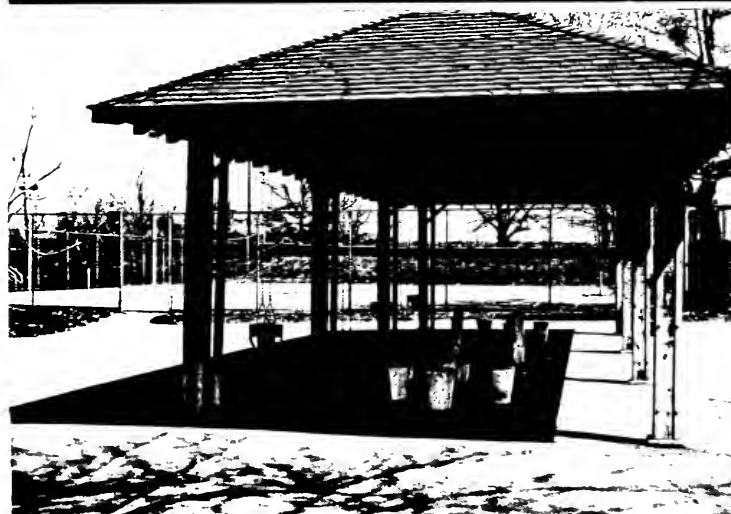
**Site Photograph 6**

New swings installed under shelter. Exposed concrete bases of picnic tables and game tables a safety hazard.

Only exposed footings and concrete bases remain from picnic and game tables that were under the open-air shelter. These should be removed and replaced with new tables.

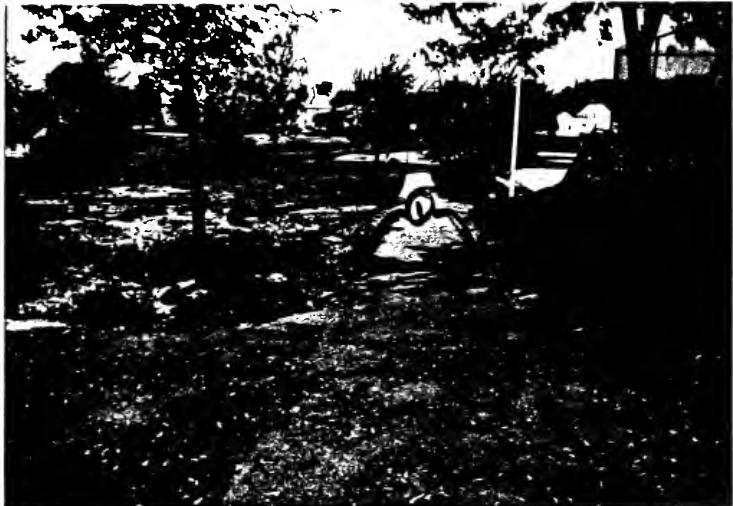
### Site Photograph 7

1. Erosion caused by storm-water flow, thin topsoil, stressed vegetation.

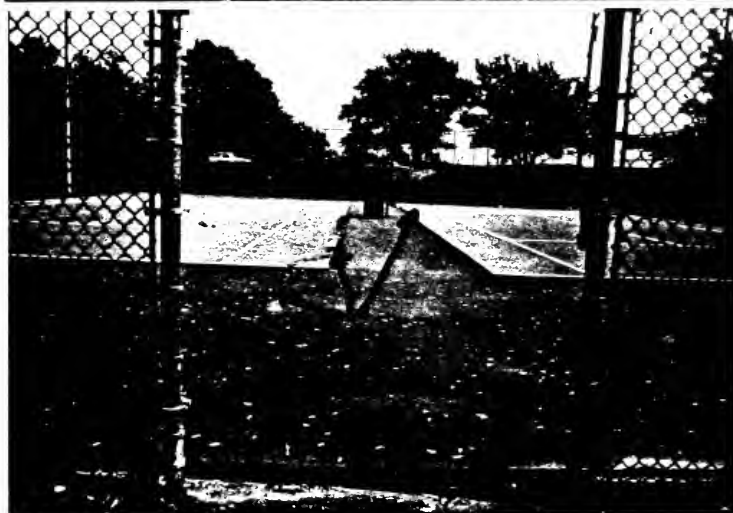
### Site Photograph 8

1. Crack in tennis court--clean out, fill with cement or bituminous concrete and seal.

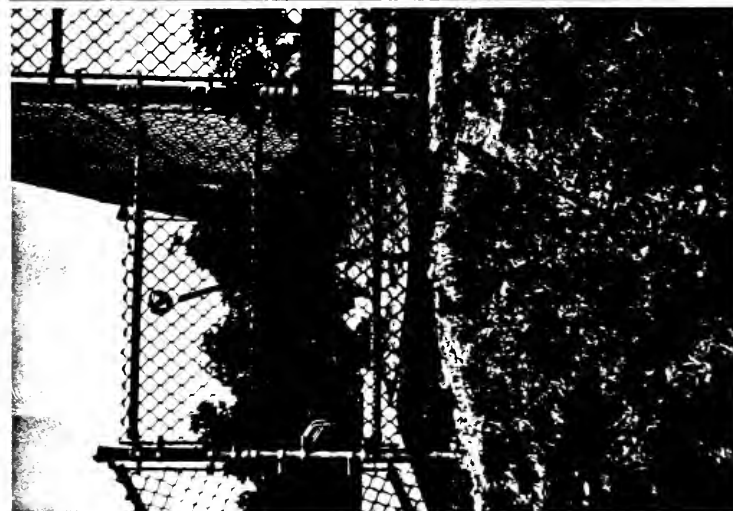
### Site Photograph 9

1. Tennis court drainage swale.
2. Erosion due to thin topsoil, poor vegetation and stormwater.

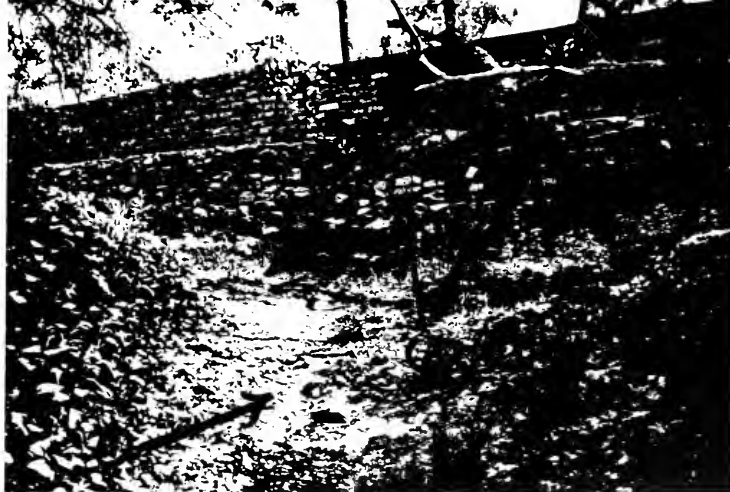
### Site Photograph 10

1. Soil erosion due to pedestrian traffic, thin topsoil, poor vegetation and storm-water drainage.
2. Loose stone fill under Milton Street and Neponset Valley Parkway.

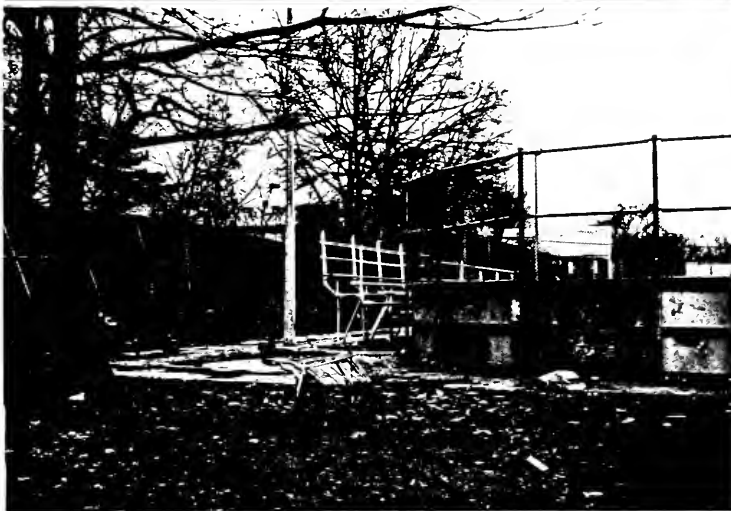
### **Site Photograph 3**

One of numerous areas showing evidence of fire. Wall needs repair, trash needs removal.

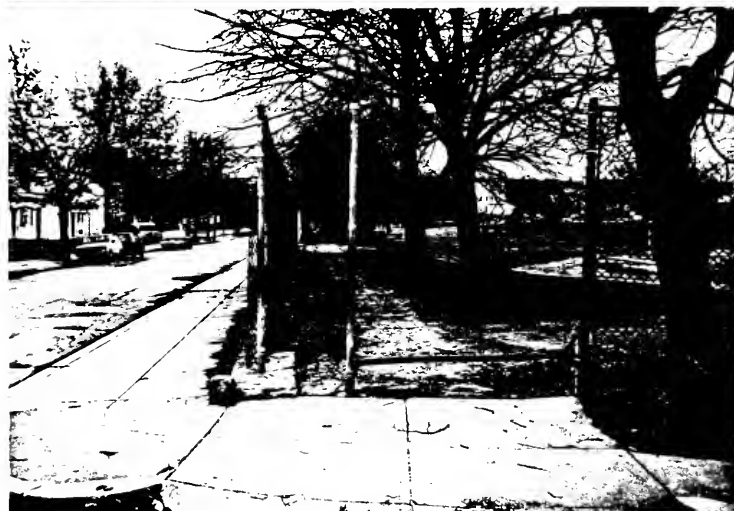
**Site Photograph 9**

Access points to park  
need to be more inviting,  
better defined.

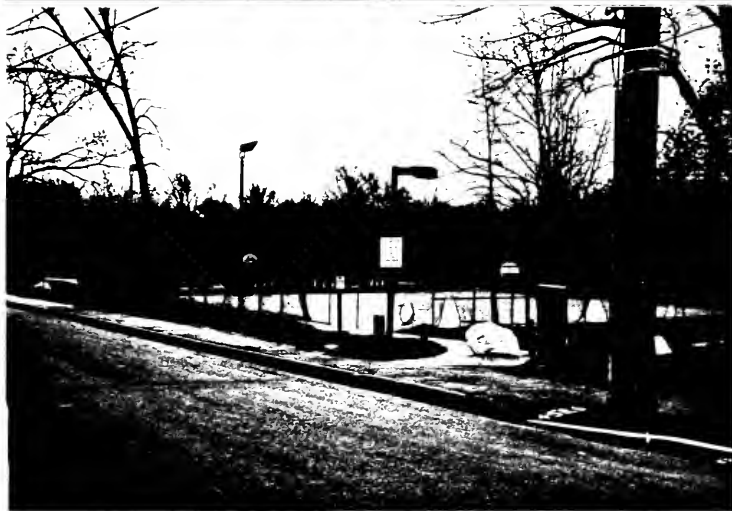
### Site Photograph 3

Painted boulder used  
for access control.  
Fencing vandalised.

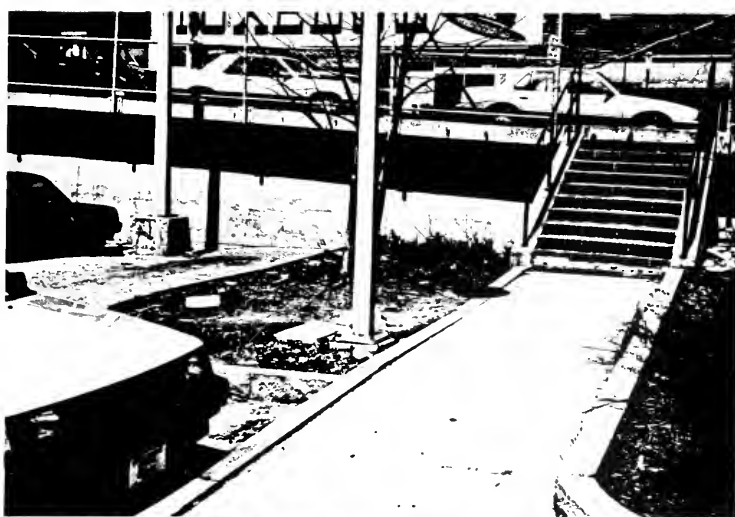
### Site Photograph 1

Shows one set of brick-faced steps and spotty planting. Soil level too low on plant beds.

The soil seems to have subsided throughout the lower level. The sidewalk does not meet the bottom of the concrete steps nor does the soil meet the top of the curbs. Additional soil is needed. The bottom step of the brick-faced steps needs repair.

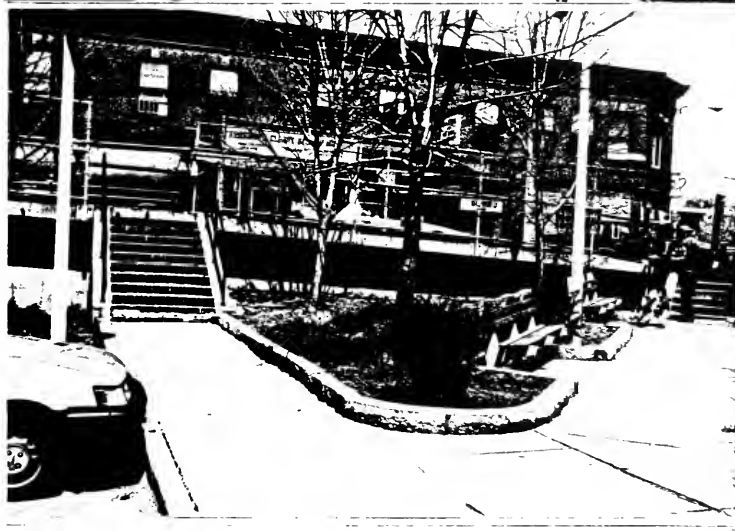
### Site Photograph 2

Planting beds need weeding, mulching and additional planting.

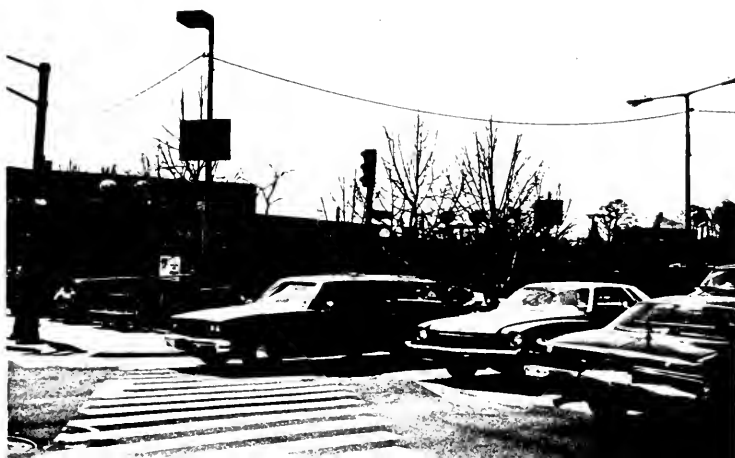
### Site Photograph 3

Park not visible from street level. Sign not well located.

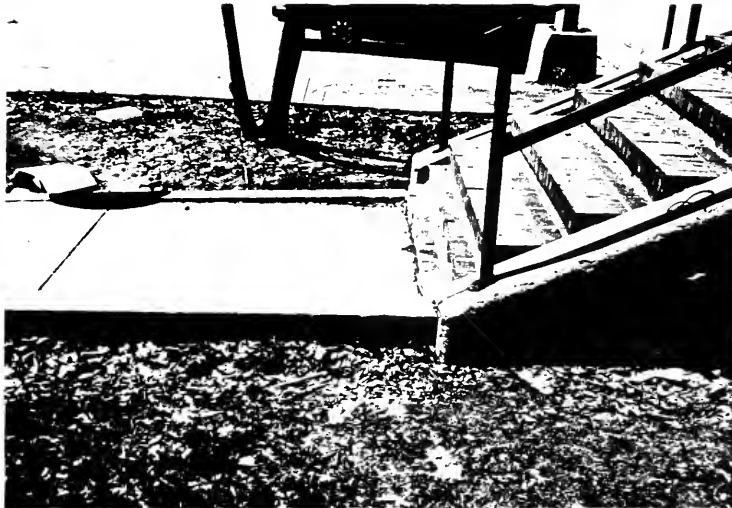
**Site Photograph 4**

Brick-faced steps -  
Bottom step a safety  
hazard.

The sidewalk, curbing, concrete stairs, railing and fencing are in good condition. The seating is mostly in fair condition. One light does not have a fixture. The trees are all in good condition, however the grass and shrubs are in poor condition. The bottom brick step is broken.

one brick step needs repair.

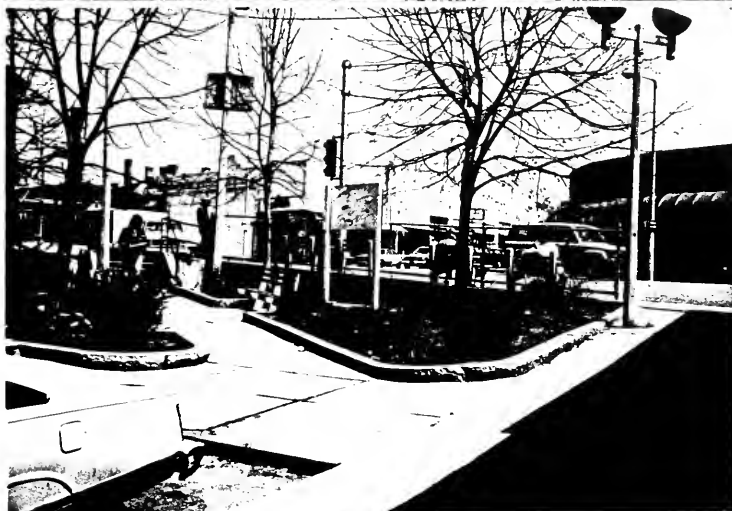
**Site Photograph 5**

Trash and weeds in  
planting bed.

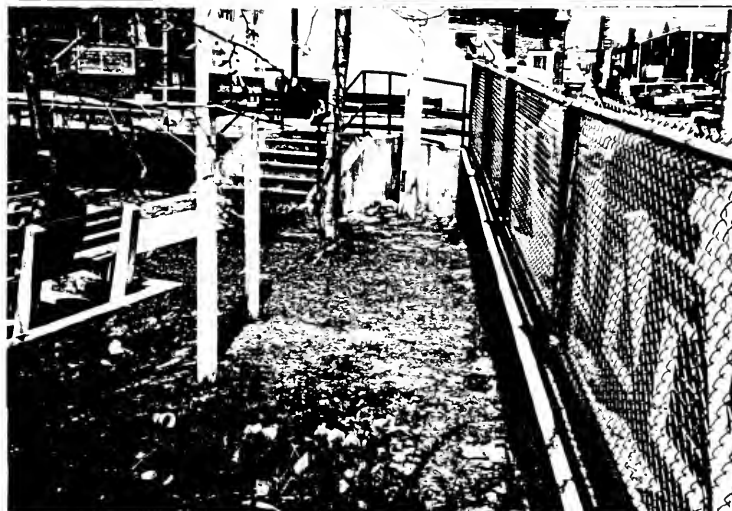
**Site Photograph 6**

Corner by steps traps  
trash. Needs cleaning.

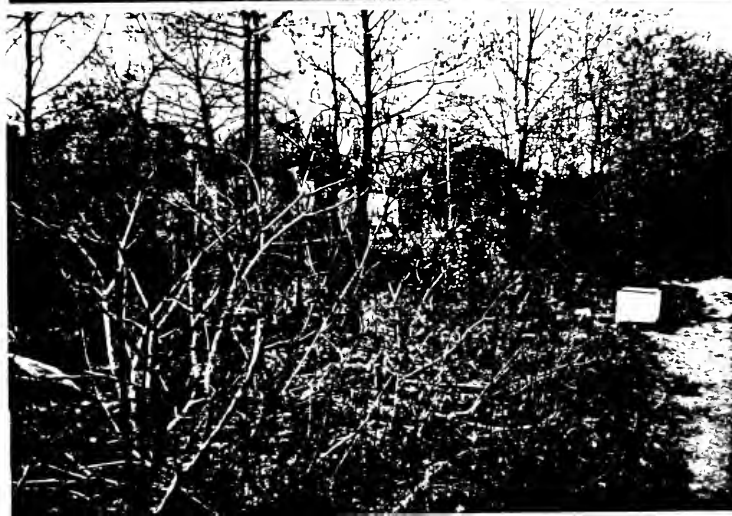
**Site Photograph 3**

Evidence of fire and  
dumped trash.

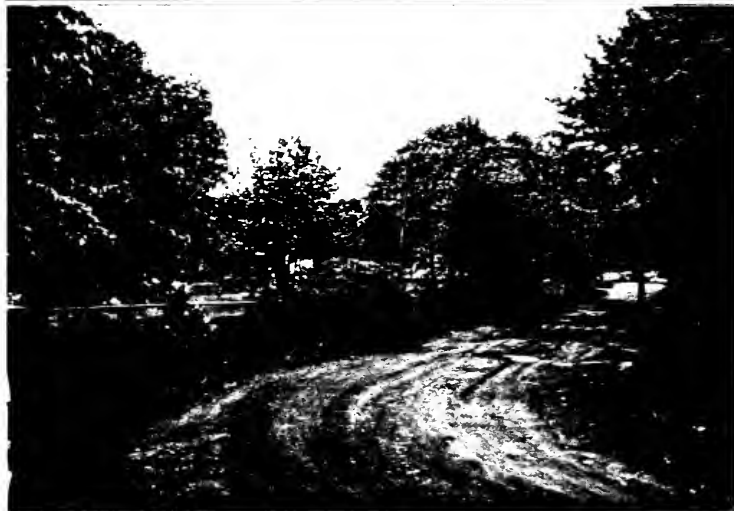
**Site Photograph 6**

Lakeside Avenue. No access through chain link fence.
